**MAJOR REHABILITATION PROJECT  
SAGAMORE HIGHWAY BRIDGE  
CAPE COD CANAL  
BOURNE, MASSACHUSETTS**

**RECONNAISSANCE REPORT**

**JULY 1977**

SUBJECT: Reconnaissance Report, Major Rehabilitation Project,  
Sagamore Highway Bridge, Cape Cod Canal, Bourne,  
Massachusetts

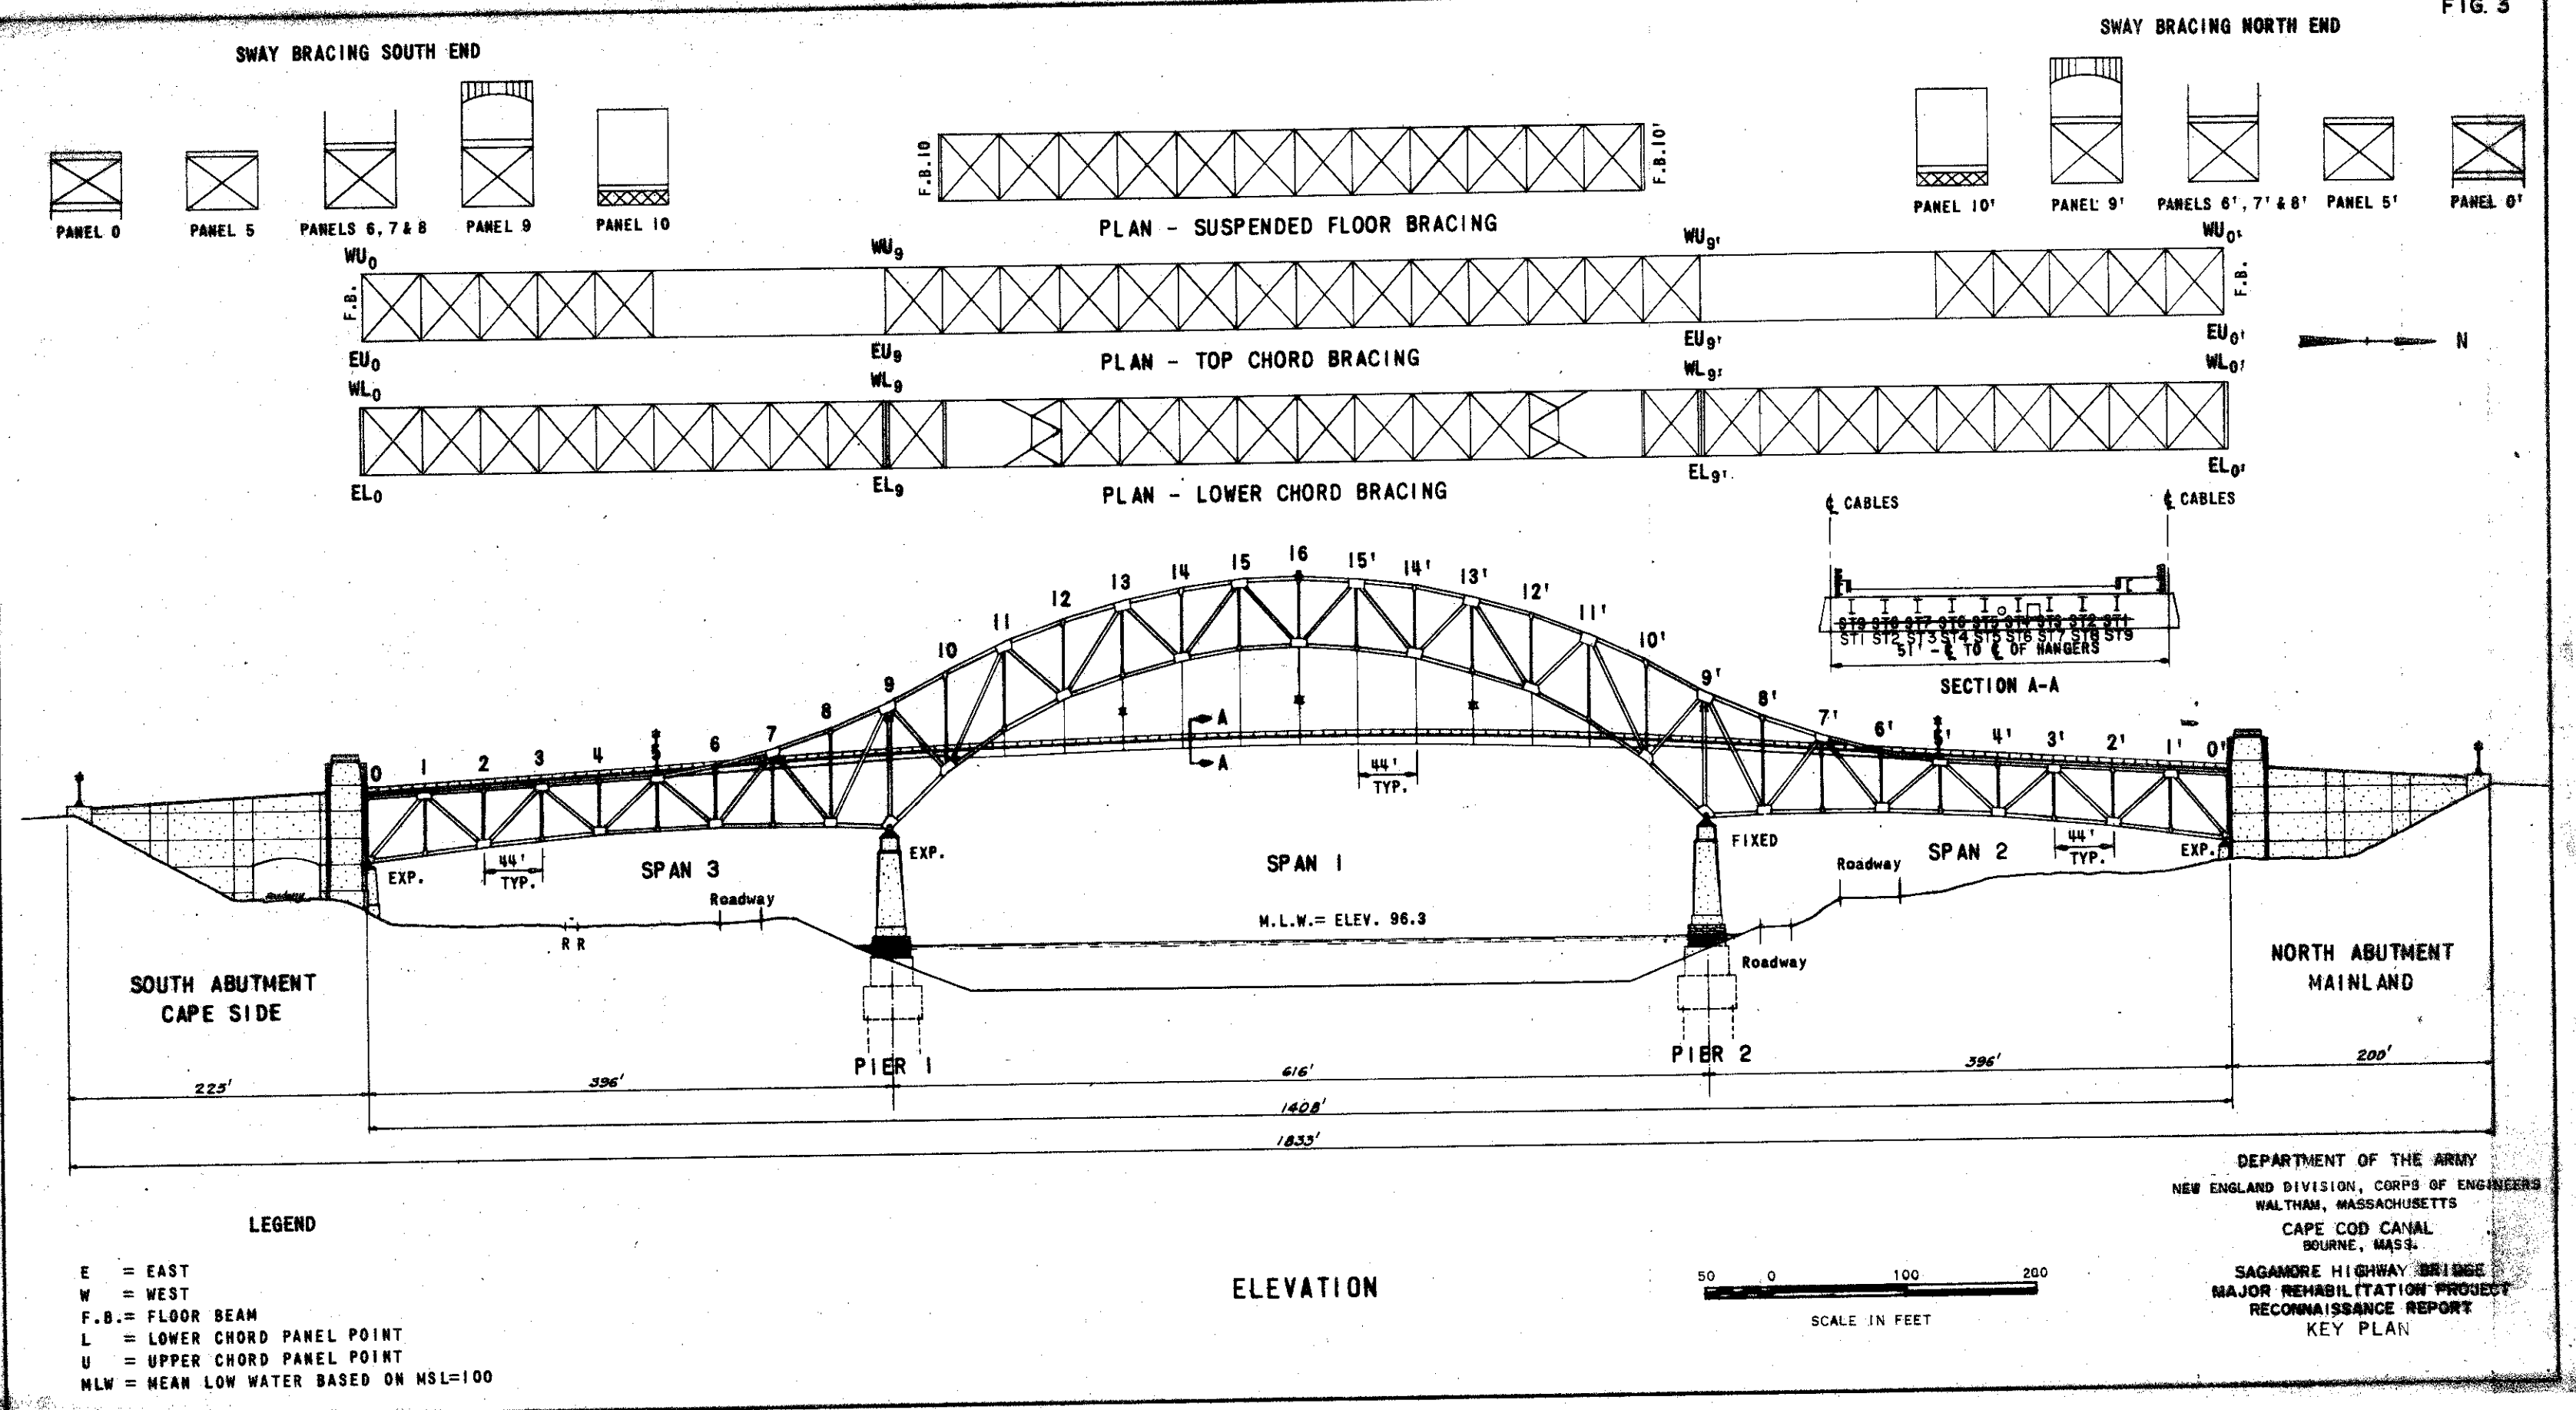
FIG. 3

e. Cable Hangers. The cable hangers which support the suspended roadway of the main span were the subject of intensive investigation and testing. The pairs of cables at panel points 14'W and 15'E (See Figure 3) were removed and replaced with new cables. The removed cables were subjected to physical and metallurgical testing to determine their strength and probable remaining life. The results of the investigations are contained in a report titled; "Sagamore and Bourne Highway Bridges-Suspender Cables-1976 Condition Report." In summary, the conclusions of that report state that the tested cables still possess the originally specified strength and that the galvanized coating has started to break down. The report further states that it will be 10 to 15 years before extensive corrosion may be expected to occur. Continued regular inspection is recommended in order to detect accelerating corrosion and certain maintenance procedures are outlined. Eventual replacement of the cables is foreseen as no known maintenance program will arrest the deterioration of the galvanized coating at critical locations. The remaining useful life of the cables places them beyond the time frame of projected repairs as recommended in the ER (5 years) and their replacement has not been included in the proposed Rehabilitation Project.
